THE MOBILE AIR CONDITIONING SOCIETY WORLDWIDE **MACS Service Reports**

By Richard McCuistian, MACS Technical Correspondent

September 2011

COOLANT, CONVECTION, AND PARTS THAT FAIL

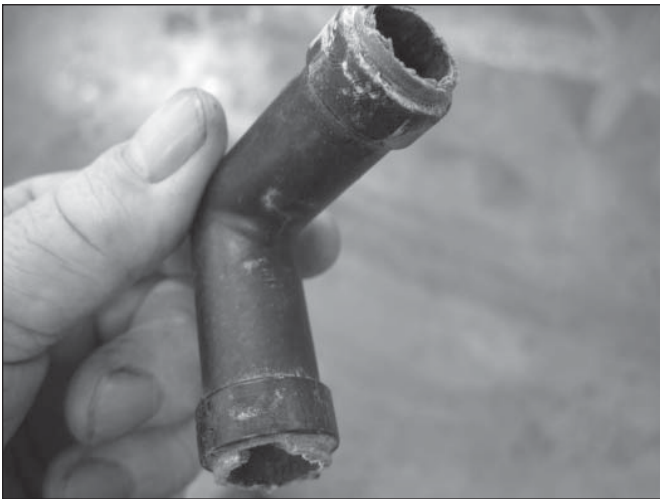
Figure 3: Coolant passes through the tensioner (as seen in Figure 1) by way of a couple of plastic elbows that routinely fail while the tensioner is still good.

GM 3.8 liter engines have two plastic elbows (Figures 3, 4) that very oddly route coolant through the belt tensioner bracket (see Figure 1), and earlier 3.8L

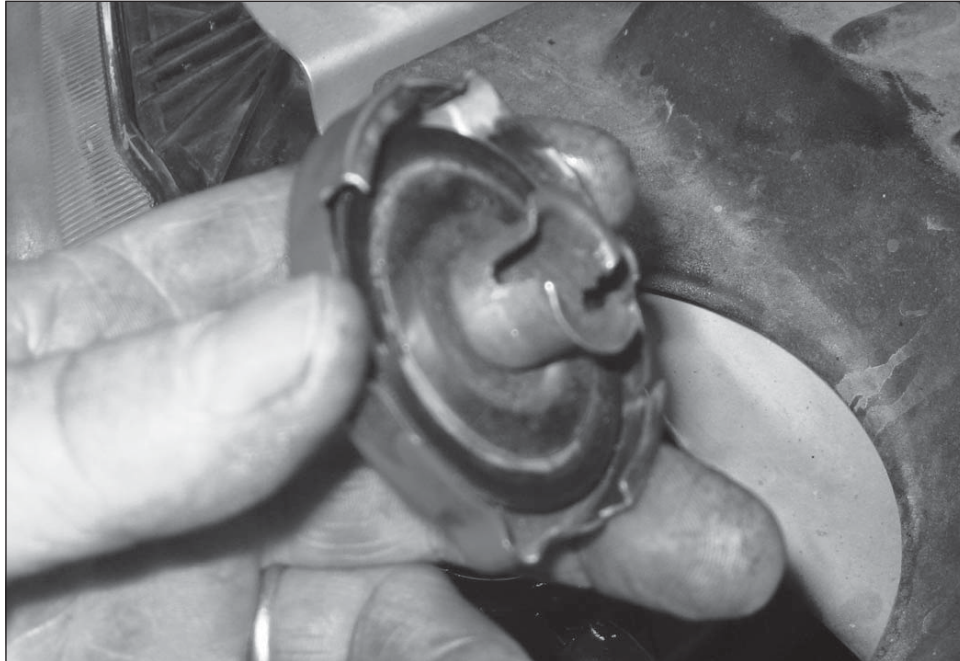
Figure 10: This is a modified radiator cap I painted red (so I remember not to leave it on) with its lower seal removed. With this cap installed, fill the cooling system as full as you can, then start the engine. The cooling system can expel air and draw in coolant as needed from the overflow bottle (you just have to watch the level in the bottle). This method builds no pressure on the system and prevents coolant surges that tend to flood the service bay and wet the serpentine belt and pulleys. Remove this cap and replace it with a good or new cap when the coolant is warm and the system is full.

When I'm filling a cooling system that has a regular radiator cap, I either use a vacuum tool (Figure 9) or I simply fill the cooling system as full as I can (opening bleeders and using hoses as necessary to cold-burp it). Then I install a radiator cap (Figure 10) from which I've removed the spring and lower seal (it still seals well around the top of the radiator neck, but lets coolant flow freely into and out of the surge bottle) and start the engine. I watch things carefully to keep 50/50 coolant/water mix in the overflow bottle. With this arrangement, the system pushes air into the bottle and draws in as much coolant as it needs to stay full. It doesn't build pressure, nor does it spew out coolant everywhere. And after everything is good and warm and the fan has cycled on and off a few times, I replace that "tool cap" with a new cap to finish the job. ■
